## 12.0 Mexican Hat, Utah, Disposal Site

### 12.1 Compliance Summary

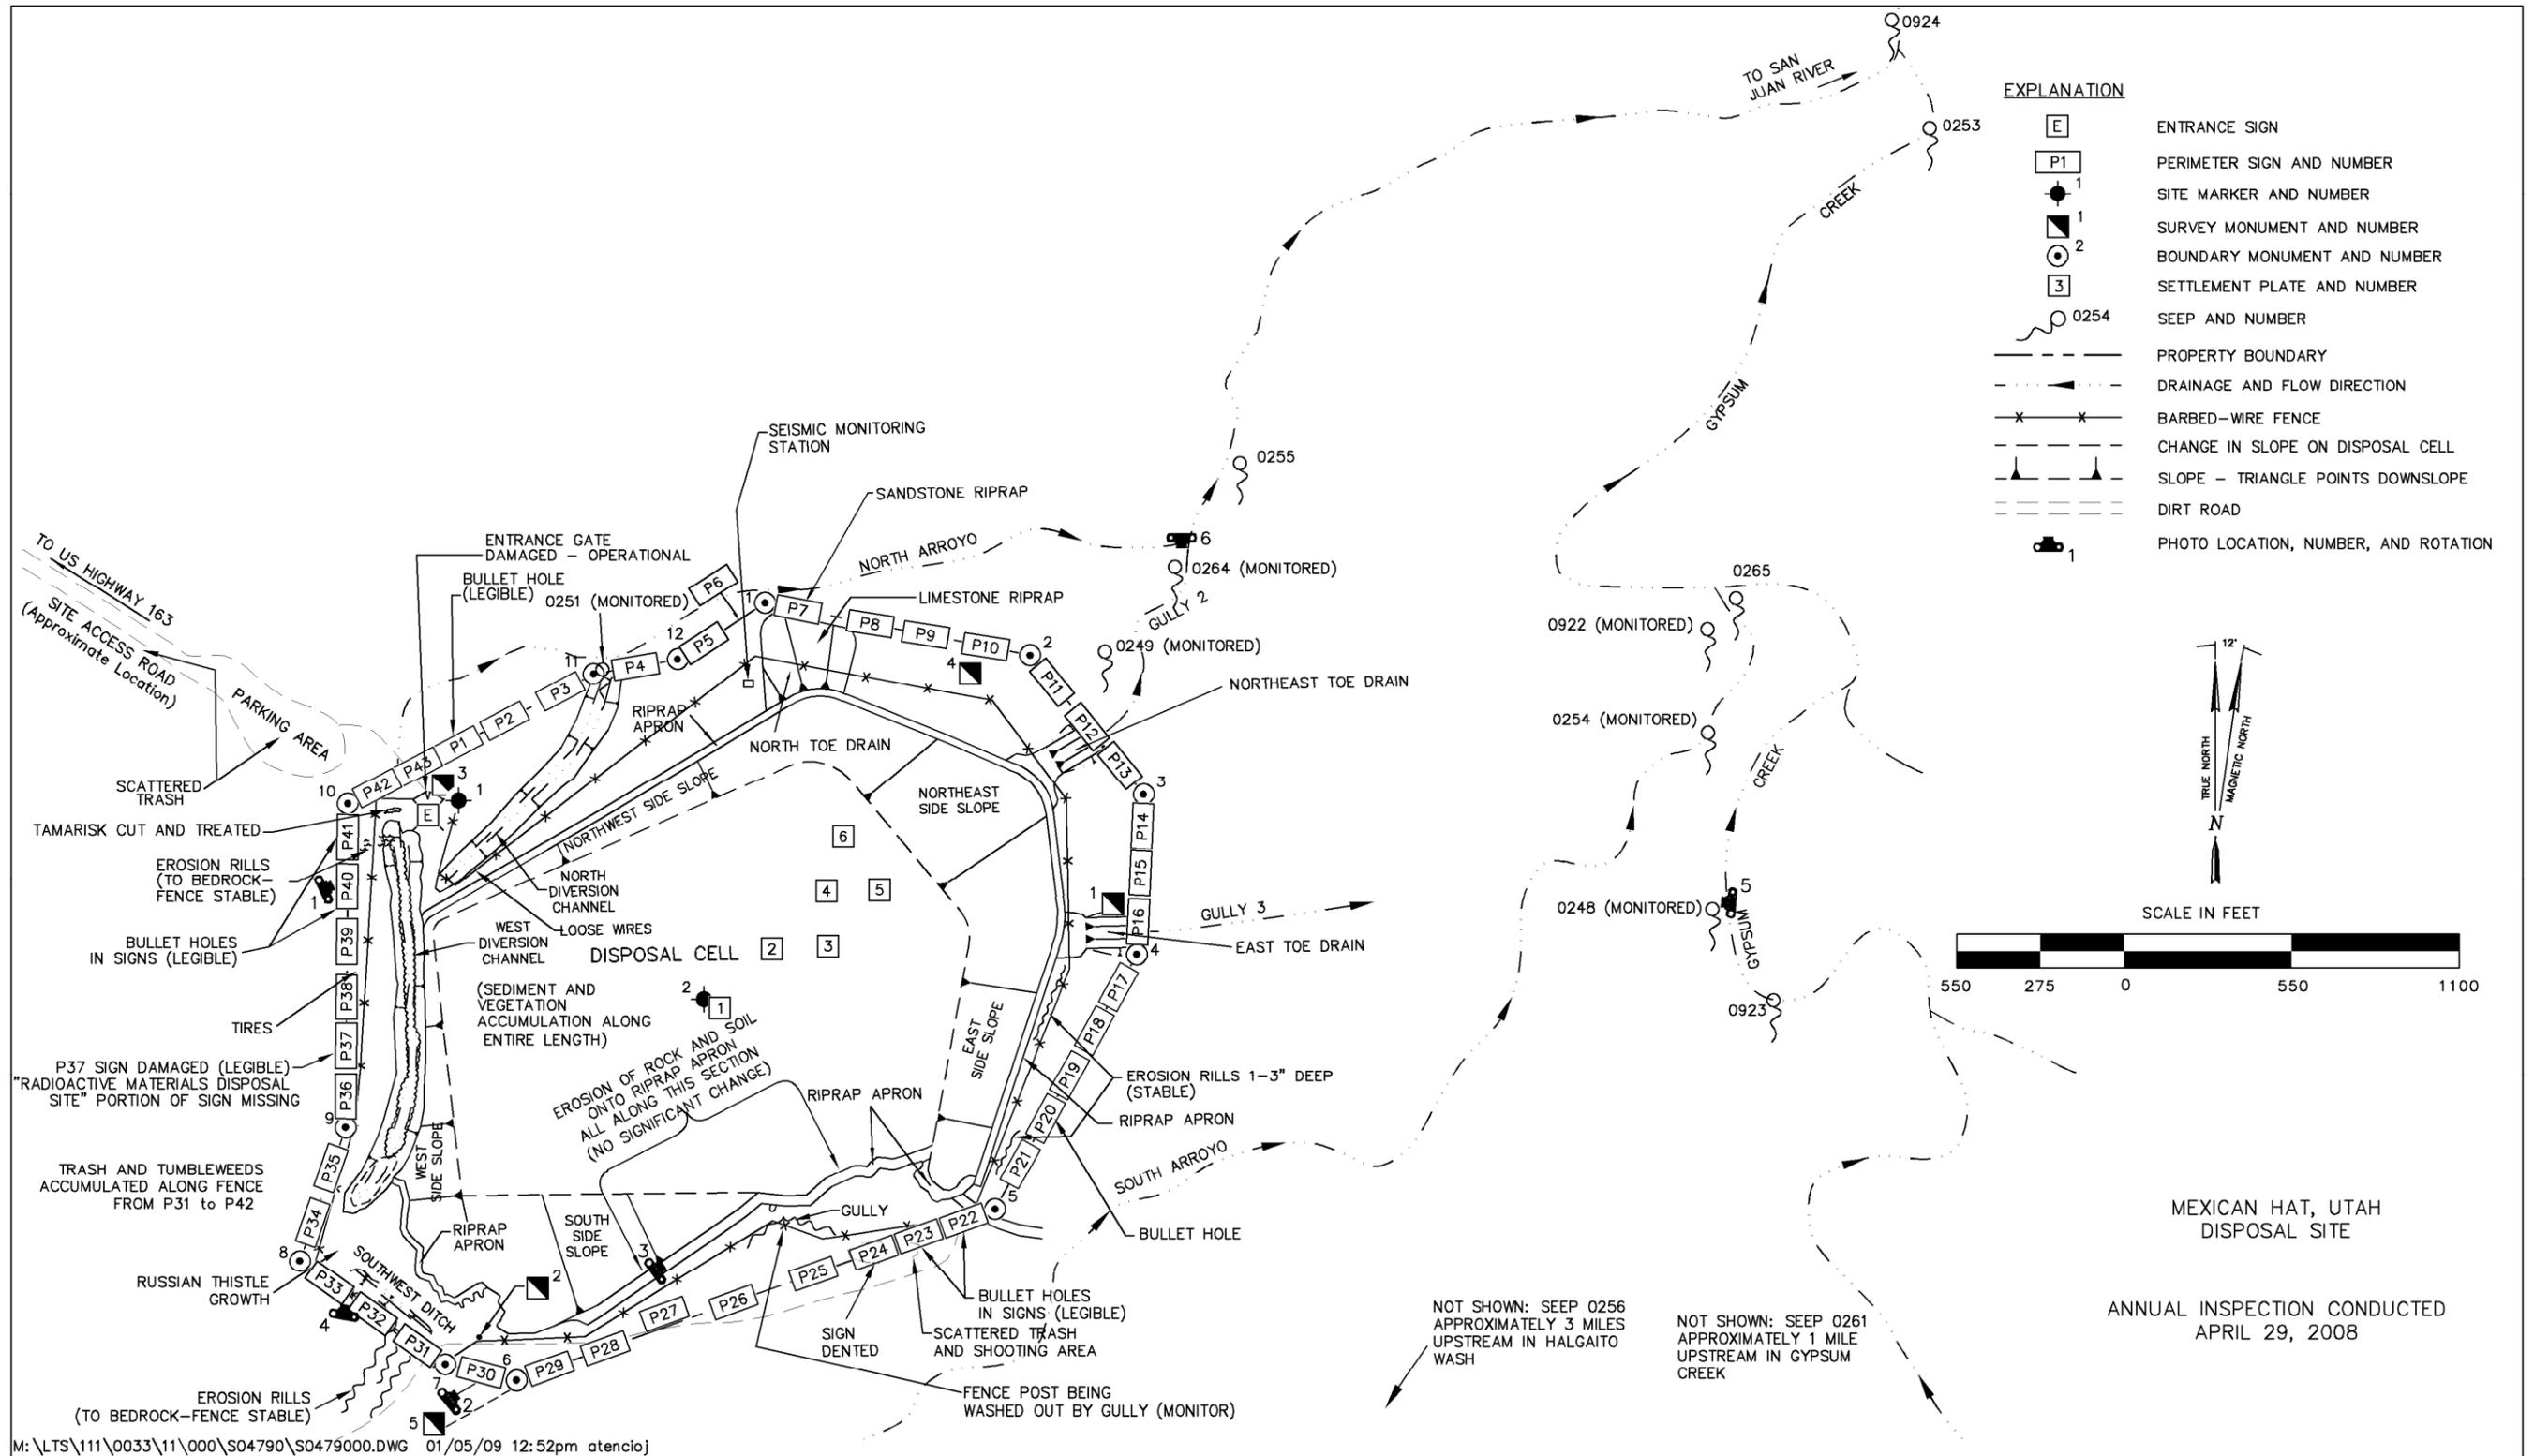
Figure 12-1. 2008 Annual Compliance Drawing for the Mexican Hat Disposal Site

A barbed-wire perimeter fence surrounds the disposal cell and is located the site boundary. Other than loose wires present at one location near the north diversion channel, the perimeter fence was in excellent condition. Periodically, the fence is damaged by livestock or erosion and requires repair.

A double-swing chain-link entrance gate is located in the perimeter fence near the northwest corner of the site. The center rod of the gate is damaged, causing the west half to be inoperable; however, vehicles can still access the site through the east half of the gate.

The entrance sign is located at the gate and was in excellent condition. There are 43 perimeter sign locations, and each location has a pair of signs: an upper property ownership sign and a lower radioactive materials disposal site warning sign. Perimeter sign P37, located along the west property boundary, was missing the lower radioactive materials disposal site warning sign. The remaining perimeter signs were present and legible, although several are bent or are damaged by bullet holes. Several signs, including P40, have new bullet holes (PL–1).

**Site Markers and Monuments**—The two site markers, four survey monuments, and 12 boundary monuments were inspected. Both site markers and all survey and boundary monuments were in good condition. Boundary monument BM–11, located in an area subject to erosion, remains stable. The markings on survey monument SM–5 are illegible; however, no action is required at this time.

**Area Between the Disposal Cell and the Site Boundary**—Erosional rills and gullies continue forming along the western edge of the site boundary primarily upgradient of, and between, boundary monuments BM-7 and BM-8. This is an expected natural process and a result of the site's stabilizing and coming to equilibrium with the outlying areas. Erosion in these areas will continue to be monitored, but it is not a concern unless it damages the perimeter fence or impacts the performance of the West Diversion Channel.
